Manhole Inspection Summary

Manhole # S37CC_028MH

Insp Date: **3/20/07 1:03 PM**

Location Address: **1003 BRENTWOOD AVE**

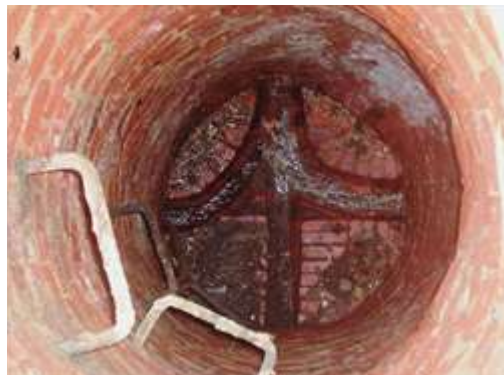
Top View

Corroded steps. Evidence of surcharge - Bench debris.

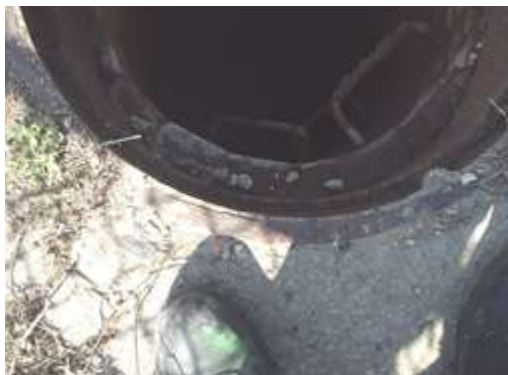
Defect

Frame offset. Adjustment infiltration.

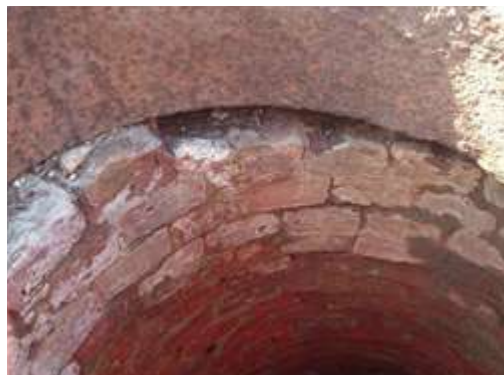
Defect

Adjustment and Corbel deterioration and infiltration.

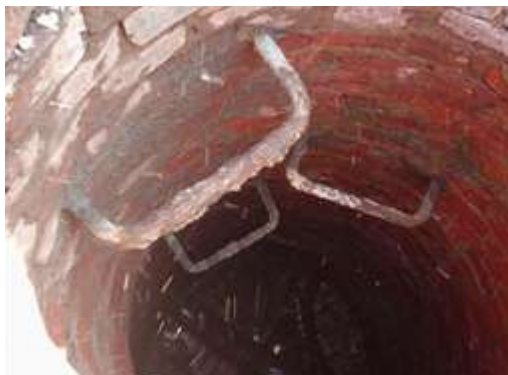
Defect

Adjustment and Corbel deterioration and infiltration.

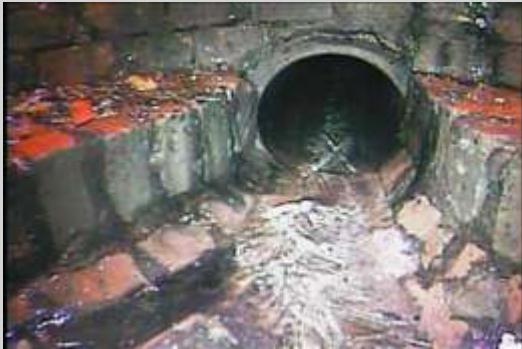
8 in. Circular Gravity Sewer Pipe Out @ 12 O'Clock

Barrel deterioration and infiltration.

Infiltration: **Evidence** Pipe Seal Cond: **Cracked**

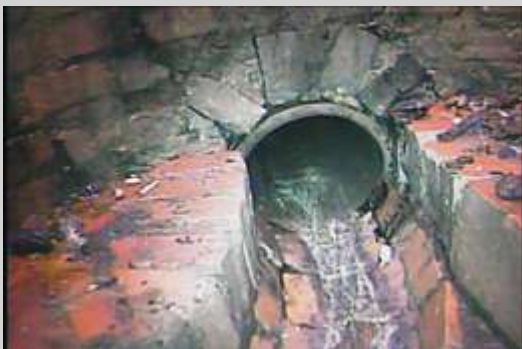
8 in. Circular Gravity Sewer Pipe In @ 3 O'Clock

Barrel deterioration and infiltration. Channel deterioration.

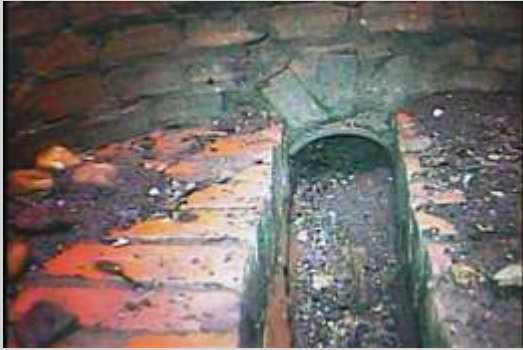
Pipe In @ 6 O'Clock

Barrel deterioration and infiltration.

Deposits: ☐ None ☒ **Mud** ☐ Sludge ☒ **Debris** ☐ Grease

Silt Depth: **3** (in.) Deposits Extent: **Medium**

Pipe Seal Cond: **Cracked**

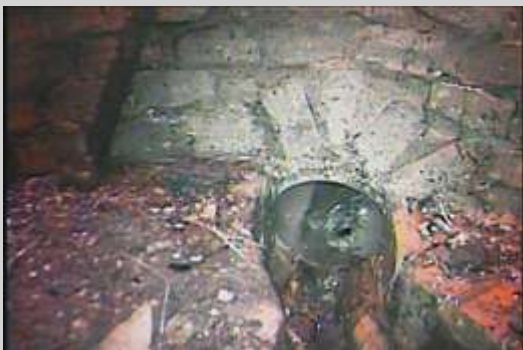
Pipe In @ 9 O'Clock

Barrel deterioration and infiltration.

Infiltration: **Evidence**
